Factors for Water Billing Accuracy

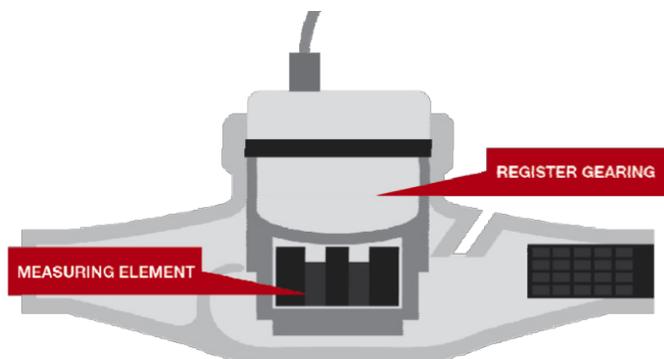
Utilities use water meters to measure water flow throughout their systems and to bill customers for their water usage. In a typical meter, the volume or speed of water flow is measured by a mechanical device. The water moving through the meter's measuring chamber causes a magnet to rotate in relation to the measuring element. A magnetically driven register records the rotations and calculates volume based on gears which are linked to the rotation speed of the measuring element magnet. These gears turn an odometer wheel which reports the corresponding volume. However, to correctly calculate the volume, the register must be the appropriate size and type for the meter or the gear ratio will be wrong. In the event the register is incorrectly matched to the meter, the meter reading may be drastically higher or lower than the actual usage.

Cross-section of a Basic Water Meter

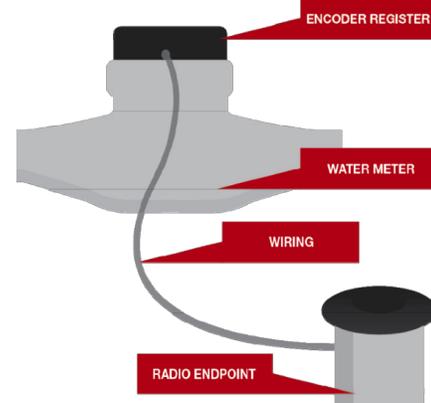
Water meter registers typically are one of three types: direct read, pulse-based (pulsar) and absolute encoder. Direct read meters have a display that must be read by a utility meter reader. Absolute encoder registers are read using an inductive probe or by a serial communication-based AMR/AMI device. Pulse-type registers generate an electronic pulse that is counted by the AMR/AMI device.

AMR/AMI Device Set-Up
